3M Australia Pty Limited
ABN 90 000 100 096

Stop Use & Field Service Action IMMEDIATE ACTION REQUIRED 3M™ ANZ L4548 SURFACE MOUNTED ROOF ANCHOR (Australia & New Zealand Only)

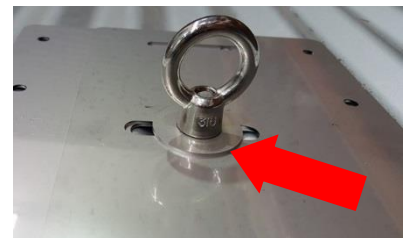
Photograph 1 Incorrect Assembly

End-users: Immediately stop using and tag out any L4548 roof anchors you have installed on your roof. Conduct a visual inspection of the roof anchor for the presence of a 50mm washer/disc between the base plate and the anchor. If the 50mm washer/disc is visible above the base plate (see photograph 1), contact 3MANZRoofAnchor@mmm to arrange to have a certified installer repair/replace your anchor at 3M's expense. If the washer/disc is visible beneath the base plate (see photograph 2), the anchor is correctly assembled and safe to use.

Installers: A list of anchors sold to you has been provided. If you have not received this list, please contact 3MANZRoofAnchor@mmm.com. If you have any L4548 roof anchors in stock, please complete the inspection as outlined above. If you find any of the pre-assembled anchors incorrectly assembled (as shown in photograph 1), please contact us to arrange a return. Also, please immediately forward this Notice to any of your customers who have had this product installed by you and provide any assistance requested by your customers to address this situation.
